## Progress Report

Installation, Operation, and Maintenance of ERH at Third Site

985 South US Highway 421  
Zionsville, Indiana

**October 2018**

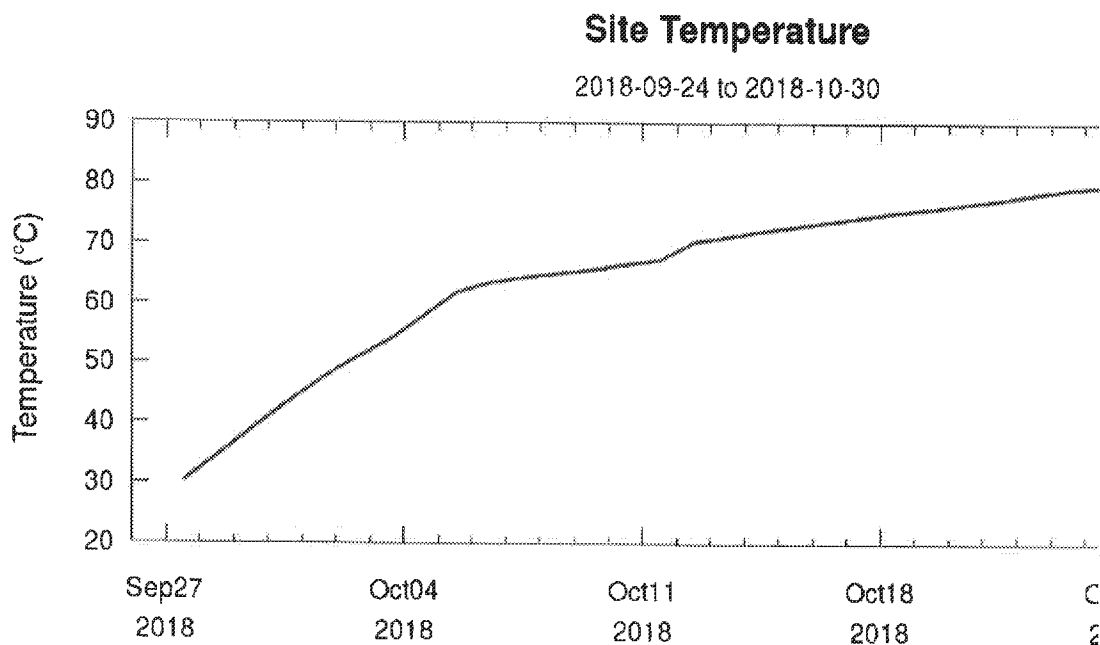
The overall heating rate of the treatment volume is ahead of the expected ET-DSP™ performance for the site. The average subsurface temperature is plotted in the following figure, based on measured temperatures at the OptiTAM® sensor wells and temperatures estimated at the electrodes from electrical energy inputs.
